TECHNICAL NOTE 3973

ORIGIN AND PREVENTION OF CRASH FIRES IN TURBOJET AIRCRAFT

By I. Irving Pinkel, Solomon Weiss, G. Merritt Preston,
and Gerard J. Pesman

Lewis Flight Propulsion Laboratory
Cleveland, Ohio

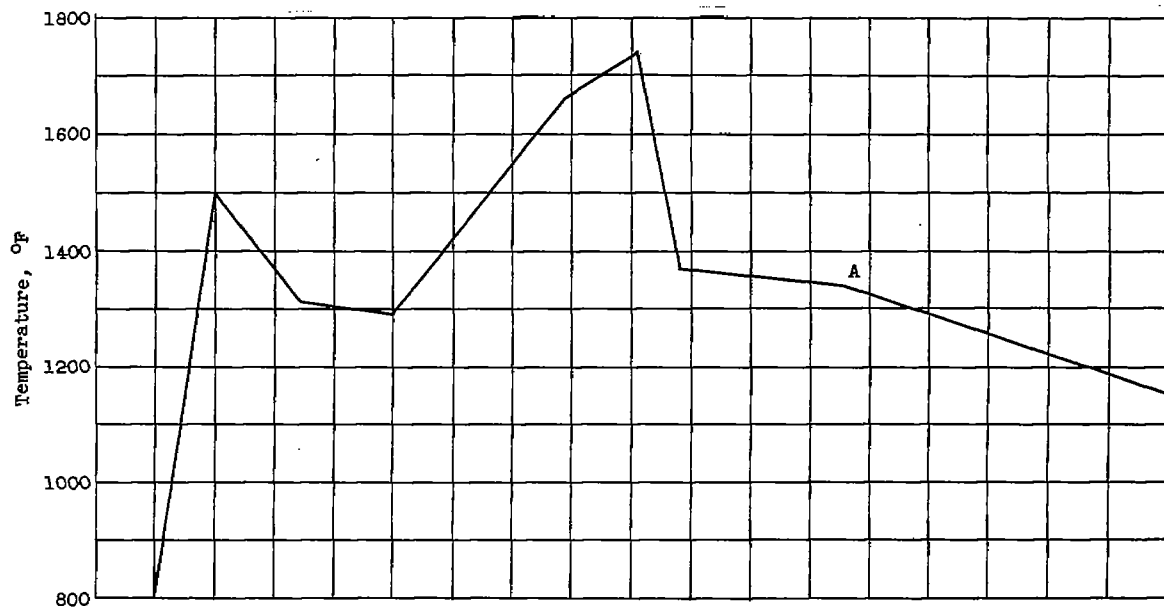
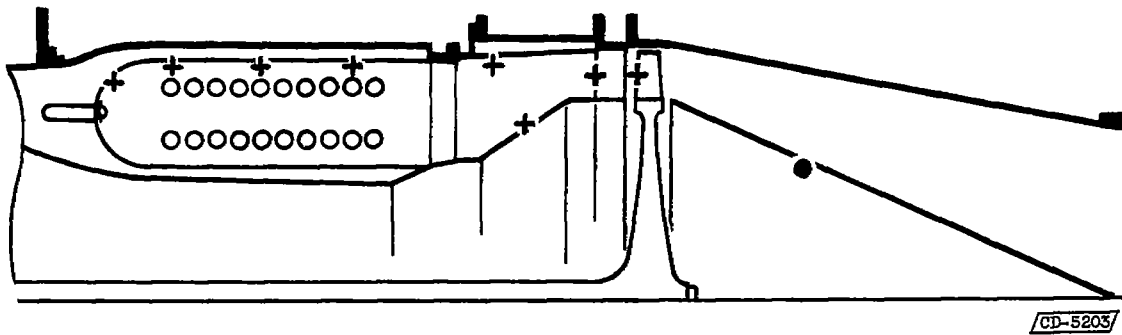
Figure 7. - Maximum temperatures of metal components in main gas streams of J47 and J35 engines.

The hottest parts of the engine, when operated at rated conditions, were those which lay in the main gas stream downstream of the compressor. The highest temperatures (fig. 7) were measured on the primary zone of the combustion liner, on the bend in the transition liner where the hot gases leaving the combustor impinge, and on the turbine nozzle vanes. Temperatures as high as 1660° and 1740° F were found on the transition liner and the adjacent turbine nozzle vanes, respectively. The stagnation gas temperature at the moving turbine blades was less than the stagnation temperature at stationary engine members in the same gas stream. The temperature of the blades was correspondingly lower, being about 1370° F for the hottest parts of the blade. The gases leaving the turbine were reduced in temperature because of the turbine work that had been done. Therefore, the temperature of the inner tailcone at location A on figure 7 was about 400° cooler than the turbine nozzle vanes. The temperature was about 1350° F at the hottest point of the inner cone and about 1150° F at its coolest point.

The largest temperature gradients occurred within the combustor (fig. 7) where some metal was in contact with the relatively cool combustor-inlet air and other metal was heated by the combustor flame. The maximum temperatures recorded were about 800° F on the dome, about 1500° F on the primary section of the combustor liner, and about 1300° F at the outlet. The lower temperatures at the combustor liner outlet were produced by the cooler secondary combustor air.

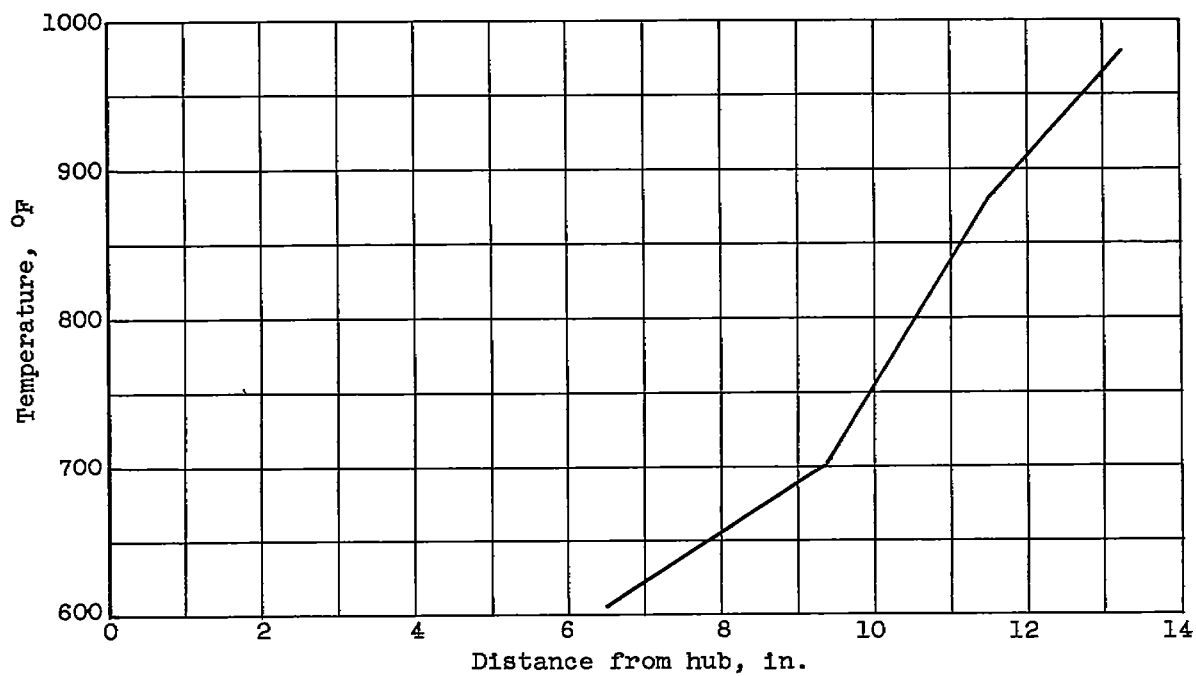
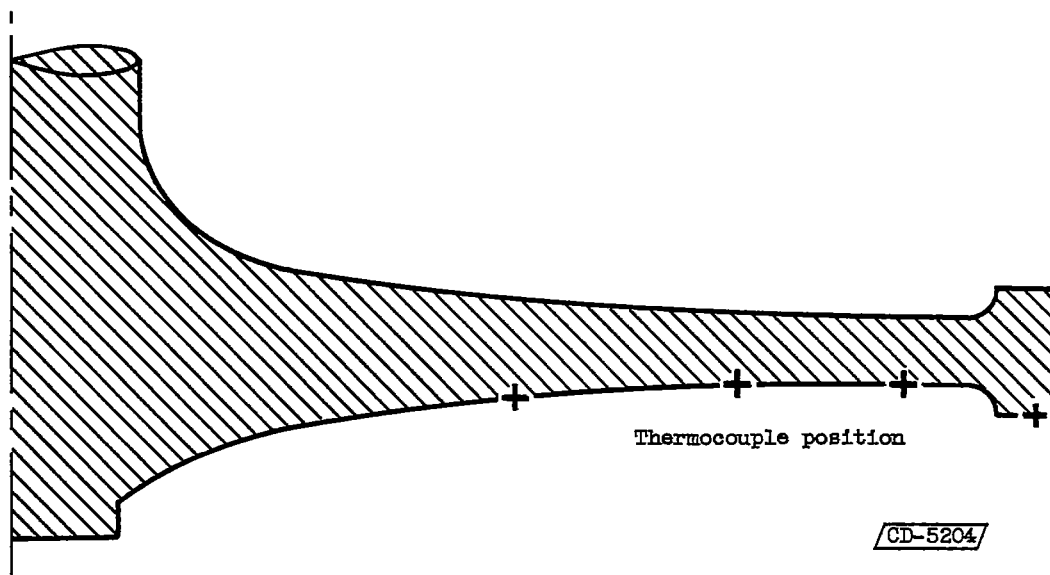
Figure 28. - Maximum temperatures recorded on J47-engine turbine wheel.

Engine parts not in the main gas stream were heated mostly by conduction. The turbine wheel was the most massive engine part heated this way. The radial variation in temperature on the surface of the turbine wheel, shown in figure 28, resulted from the fact that the heat conduction was from the wheel rim to the relatively cool hub. The data shown were obtained with the engine operating at rated sea-level conditions. The turbine-wheel surface temperature varied from approximately 980° F at the rim to about 605° F at a point midway between the rim and hub. Cooling air from the compressor applied to the hub to protect the engine bearings maintained this temperature pattern.

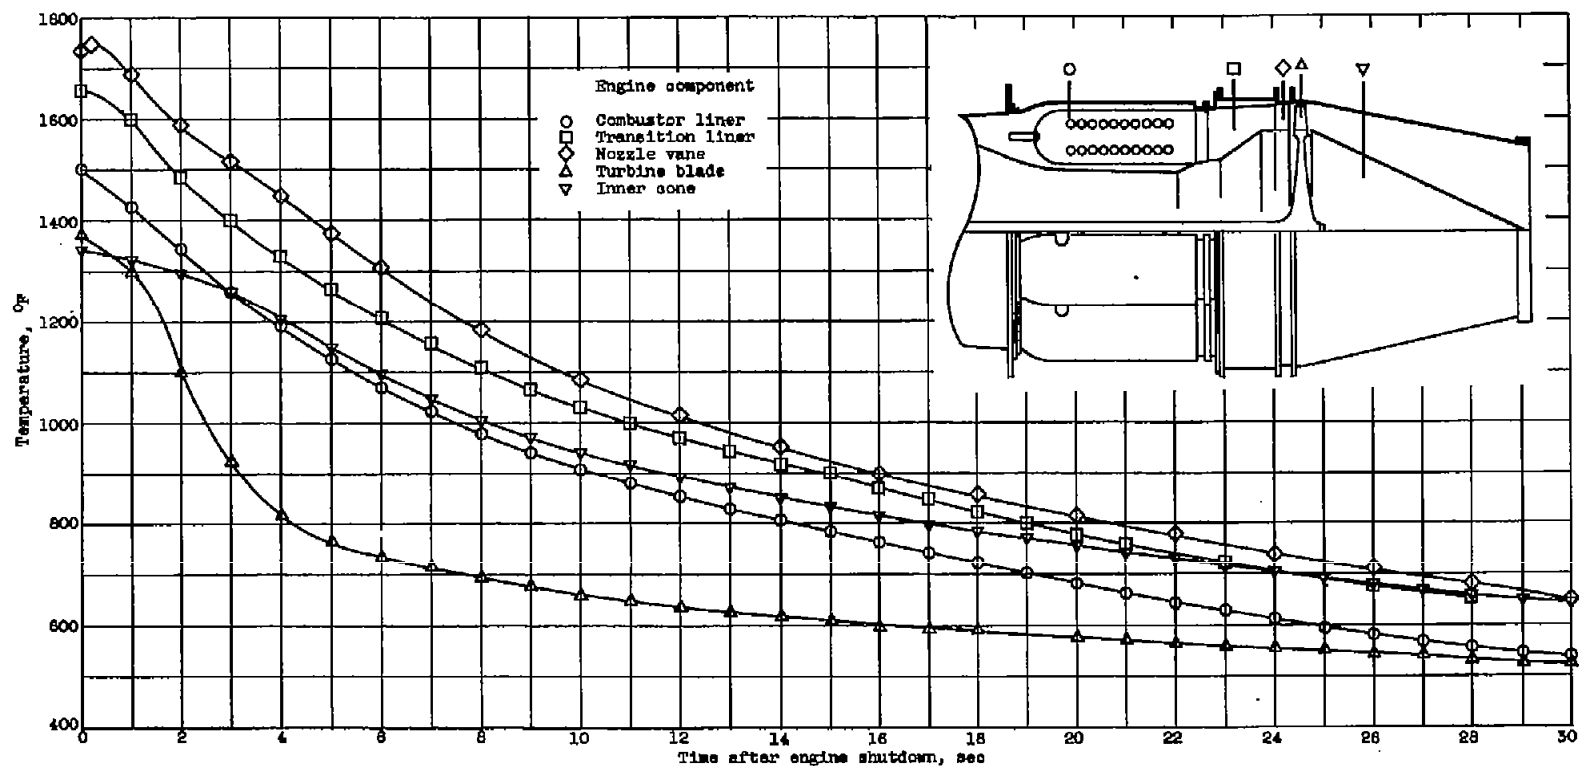
Figure 29. - History of maximum temperatures on engine components in main gas stream.

A history of the temperature of engine parts lying in the main gas stream is shown in figure 29. Fuel shutoff occurred at zero second, and the temperatures indicated were the maximum recorded anywhere on the component at the time noted. The hottest section of the combustion-chamber liner cooled from 1500° to 600° F in $24\frac{1}{2}$ seconds. It took over 30 seconds for the transition-liner temperature to decline from 1660° to 600° F. In 30 seconds the turbine nozzle-vane temperature dropped from a maximum temperature of 1750° to 645° F. The rotating turbine blade temperature fell from 1370° to 600° F in 16 seconds. Inner-cone skin temperatures declined from 1340° to 640° F in 30 seconds.

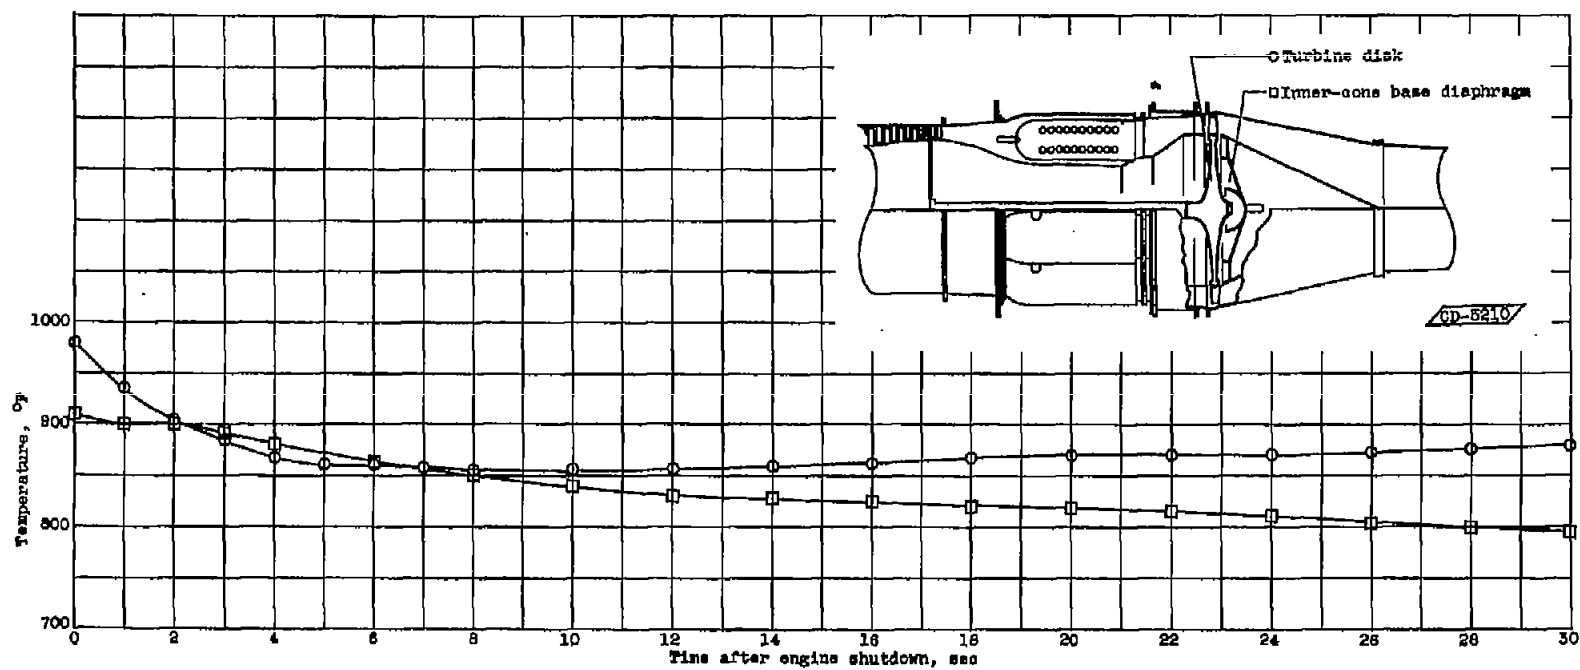
Figure 30. - History of maximum temperatures on turbine disk and inner-cone base diaphragm.

Engine parts not located in the main gas stream declined in temperature at much slower rates (fig. 30). The hottest part of the turbine wheel was initially at 980° F and dropped only 100° F in 30 seconds after fuel flow to the engine had stopped. The turbine wheel remained above the ignition temperature of JP-4 fuel for 30 minutes after the engine was shut down. The large mass of the turbine disk contributed to its slow cooling rate. The inner-cone base diaphragm exhibited the same slow rate of cooling. Its maximum temperature was 910° F and cooled only approximately 115° F in 30 seconds.

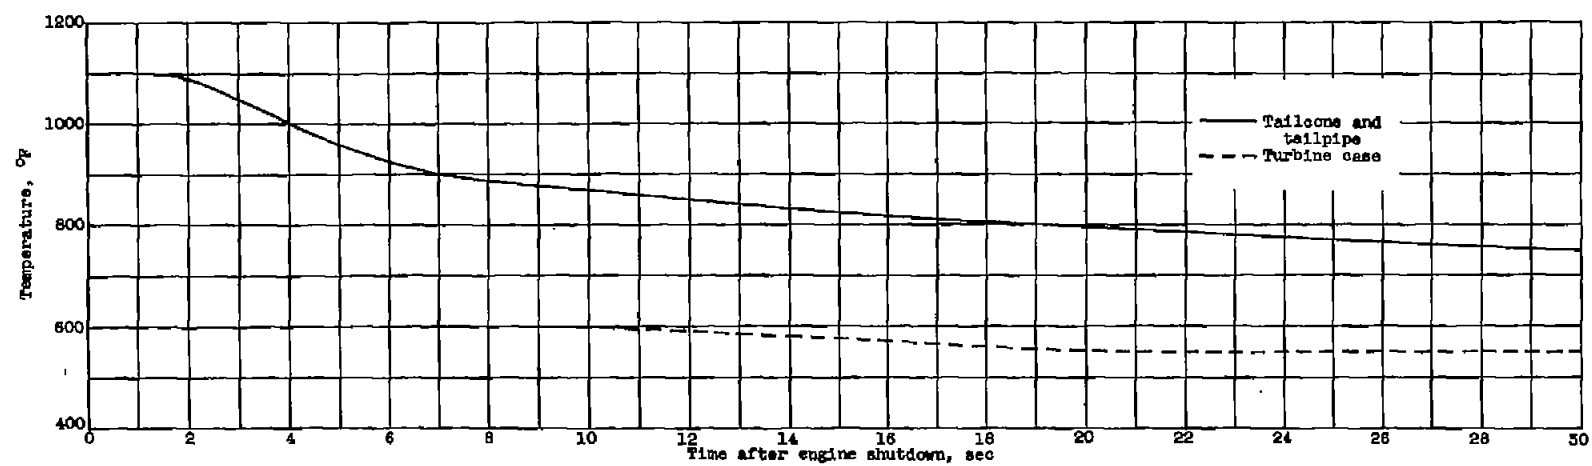
Figure 31. - History of maximum external skin temperatures on J47 turbine case and tailcone and tailpipe.

Temperature measurements made on the external skin of the J47 engine (fig. 31) indicated that the tailcone and tailpipe temperatures remained above 600° F for more than 30 seconds after the fuel to the combustor was shut off. Temperatures of the engine case upstream of the tailcone and tailpipe were usually below 600° F (fig. 32). Although the turbine case reached a maximum temperature of 600° F and remained so for 10 seconds after the fuel was shut off (fig. 31), no ignitions were experienced here.

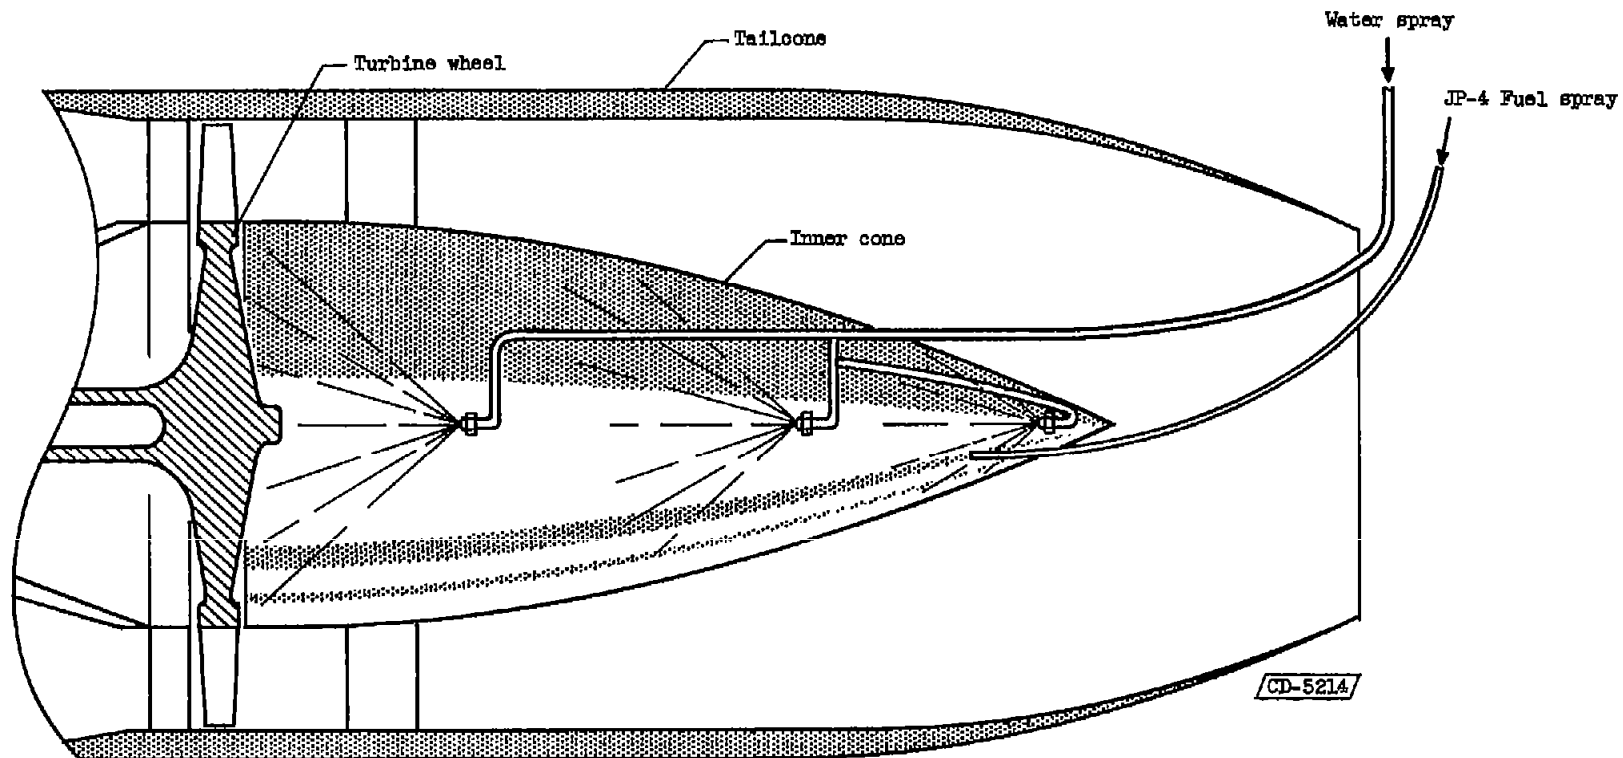
Figure 34. - Sketch of typical equipment used to study ignition hazard (J30 inner tailcone).

The engine cavity farthest downstream, the inner tailcone, was studied first. The arrangements used for the J30 tailcone are shown schematically in figure 34. A fuel system, consisting of a single tube and nozzle, was arranged to spray fuel in measured quantities into the cavity of the tailcone to produce a combustible atmosphere. In addition, three water spray nozzles were installed facing the upstream direction. Since the J30 engine has no base diaphragm, the downstream face of the turbine wheel must be taken as a bounding surface of this cavity. The upstream water nozzle was arranged to spray water on the turbine wheel to avoid ignition from this source.

Following this evaluation of the tailcone interior as an ignition hazard the runs were repeated, but this time the water sprays were also turned on with the fuel spray in the tailcone. Initially, sufficient water was used to ensure absence of ignition. By progressively reducing the water quantity in repeated runs a minimum water requirement was established below which ignition would sometimes occur.
